CASE

Problem

A Nashville, Tennessee business park fountain, about 120 feet long, with widths varying from 15 down to 10 feet, and a depth of 2 feet 6 inches, had been built 20 years ago and its rubberized lining was failing badly to the point of causing substantial leakage directly into the ground, necessitating frequent top ups.

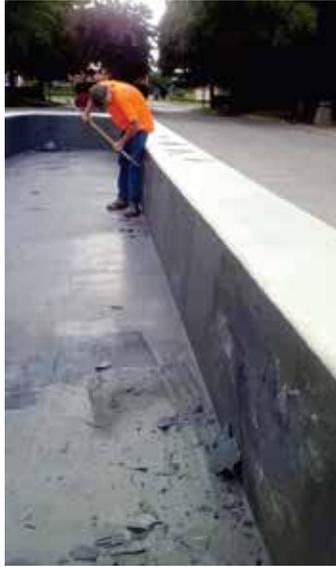
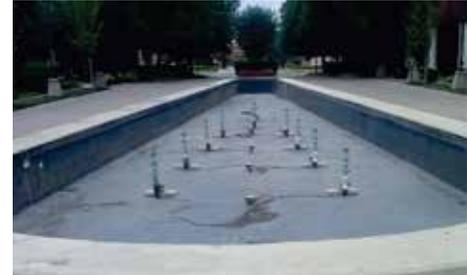
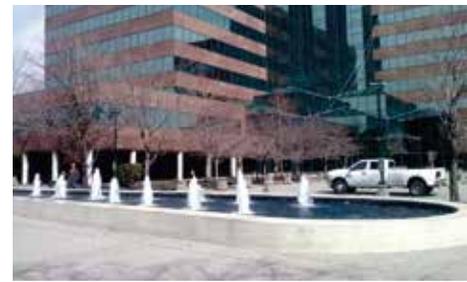
A common problem with fountains is created by members of the public throwing in small change. In this case, copper coins had reacted with the chlorine in the water and appeared to have seriously accelerated corrosion of the lining.

The applicator had conducted tests and was satisfied that, subject to an adequate preparation of the existing liner with removal of the degraded patches, that an Ecodur overcoat to 50 mils, would provide a tough, permanent non-toxic seal that could, if ever necessary, be perfectly repaired at any point in the future as Ecodur has a near unlimited ability to re-bond to itself due to its unique chemistry.

General site preparation, including the removal of the damaged area took three days. There was a two-week pause for electrical work to be carried out by another contractor. The applicator returned and had to do some additional clean up from the electricians' activities.

50-60 gallons of dark grey Ecodur 2015 was sprayed during one daylight shift in dry, unshaded hot temperatures in the 90 degree Fahrenheit range. Tack free dryness was achieved in 30 minutes and full cure and final sign-off post inspection was completed within 24 hours.
