## CASE STUDY: BUILT-UP ROOF REPAIR

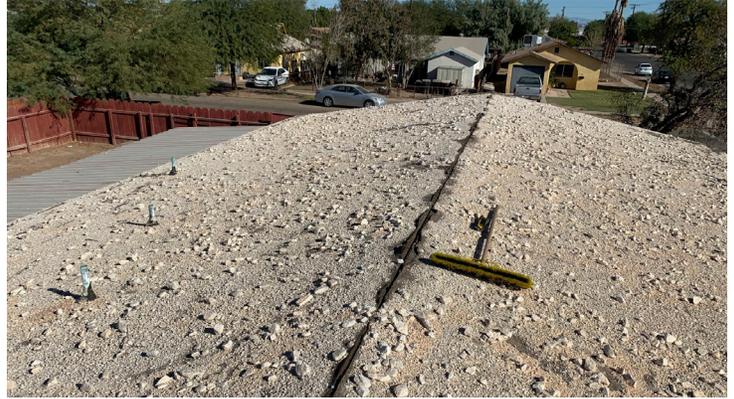
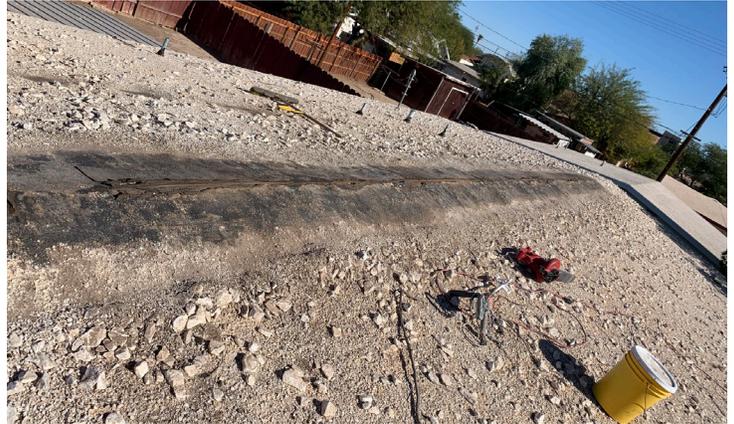
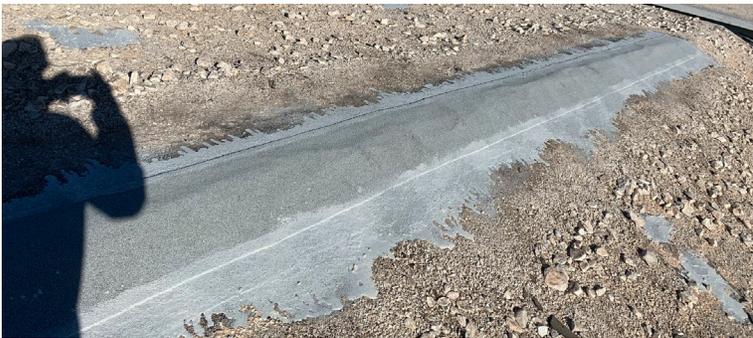
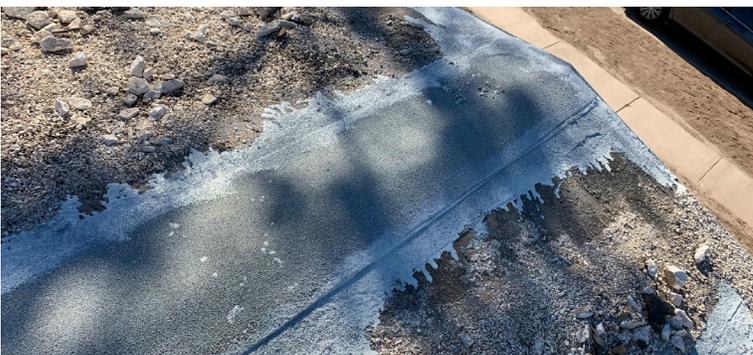
Some built-up roofs use a layer of gravel to protect the asphalt layer from harmful UV rays. When areas of the gravel become bare, the asphalt underneath is exposed to the sun's rays. This creates brittle spots that eventually will chalk and wash away with the next rain. As the layers continue through these chalking and washing cycles, the rate of deterioration increases, and the trouble areas become bigger and bigger. This roof had approximately 30 areas so bare that many of them were exposed to the wood sheathing. To make matters worse, the ridge had fallen apart so badly that there was a large gap between the opposing sides.

Along the ridge, all loose gravel was broomed back at least a foot, allowing for scraping of loosely embedded gravel and creating a smoother surface for the incoming mineral cap. A layer of felt was fastened along the ridge and a 12" roll of mineral cap was carefully torched to it. To ensure water tightness, mastic grade Ecodur was applied around the entire perimeter as well as at each seam.

Next, each of the 30+ holes, bad seams, bad edges, and other trouble spots was scrubbed with a wire brush and blown free of loose debris. Using Ecodur thickened to mastic grade, each trouble area was overfilled to prevent any water from sneaking past its guard.

After curing, the gravel was broomed back over the repair areas making them practically invisible from the ground.
