CASE

A 1,000 barrel content water injection tank for Legacy in Wyoming was badly affected by corrosion. High H₂S, sulfur content water at 145 degrees Fahrenheit was being stored. The tank had severe pitting from floor to ceiling. It is common for us to see pits like these on the floor and up the wall 24" or so, but this tank was pitted all over. It had been fiber glassed and then coated over.

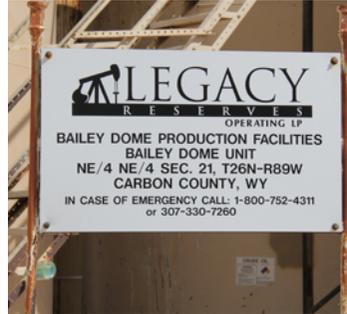
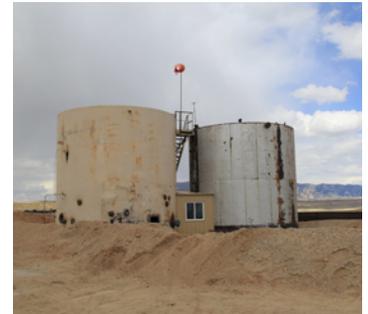
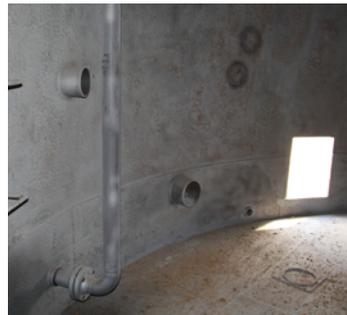
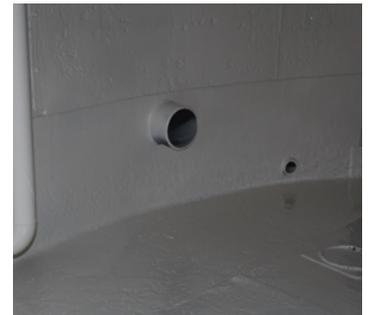
Unprotected fiberglass (Fiber Reinforced Plastic) is highly susceptible to water incursion and/or sun damage depending on the resin used. Water incursion will cause blistering or bubbling, though this typically takes years to show. Once this process starts, extensive delamination eventually occurs further facilitating the movement of water across tank walls. With the relatively high acidity of the tank's contents, acid attack was the main culprit causing the highly extensive pitting. The original protective coating appears to have failed early, likely being susceptible to large variations in temperature causing the steel to expand and contract. Conventional epoxies have poor resistance to mechanical shock and contraction/expansions. Micro-cracking commonly occurs within days or weeks letting in acidic vapors and liquids that get absorbed by the fiberglass and attack the steel.

Castagra's Ecodur 2015 is the ideal coating for severe corrosion. Once the surfaces have been prepped and totally de-scaled, it is particularly effective at filling and permanently protecting pits from further incursion of corrosive liquids as Ecodur has extreme resistance to sulphuric acids commonly encountered in oil tanks. Because of its retained elasticity, it also maintains its integrity in tanks subject to high ambient temperature variations and high temperature contents such as this case. Typically for exposed bolt heads, an extra layer of Ecodur is often applied as these are particularly vulnerable parts of a tank.

The tank has been restored to full use and inspection has shown complete integrity. It is estimated the tank will have an extended operating life well beyond the one it would have had if no remediation had been carried out, and certainly well beyond any remediation carried out with conventional epoxies.
