# CASE

Abundant, clean drinking water is pretty much taken for granted, but it hasn't been by water authorities for a long time, particularly since 9/11. It is a highly vulnerable resource that needs protecting both from the security point of view and content. Many are now in secured properties such as the two covered 12 million gallon storage facilities at the Martinez Treatment Plant in Tempe, Arizona.

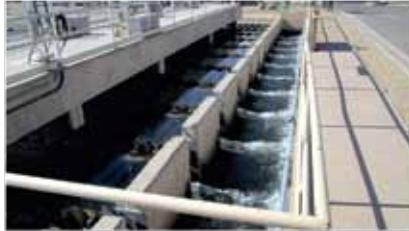
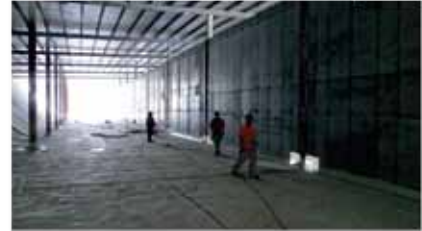
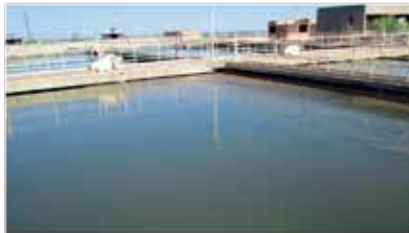
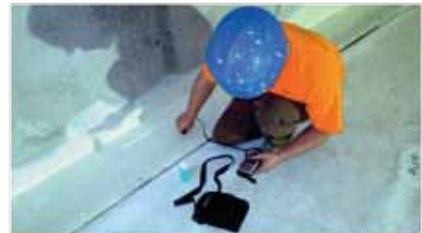
Combined they make what we call a veggie plastic with unique protective qualities, most particularly its toughness and longevity under the harshest off conditions without decomposing, thus making it ideal for complex applications such as this Tempe reservoir where very old concrete needed a new lease on life. A 50mm -100mm Ecodur coating was applied which is two to five times the normal thickness applied to oil tanks.

The project, carried out by Colorado Lining, took two weeks to complete. A full inspection of the hundreds of fastening points, the bases of walls, seams, and column points, showed full integrity both before and after the reservoir was re-filled.
