## CASE STUDY: OCEANFRONT HOUSE

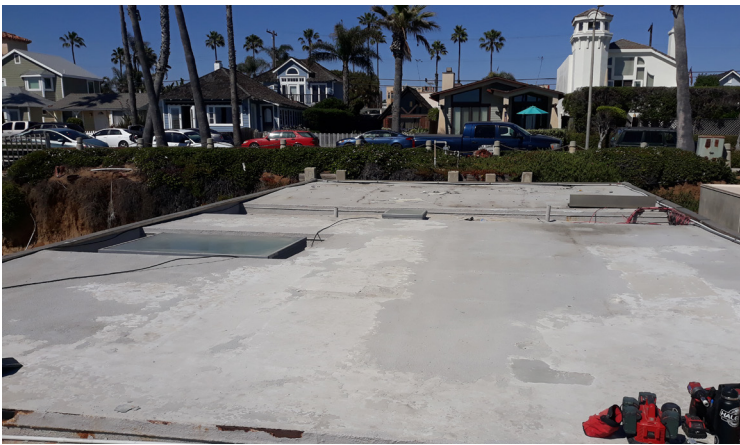
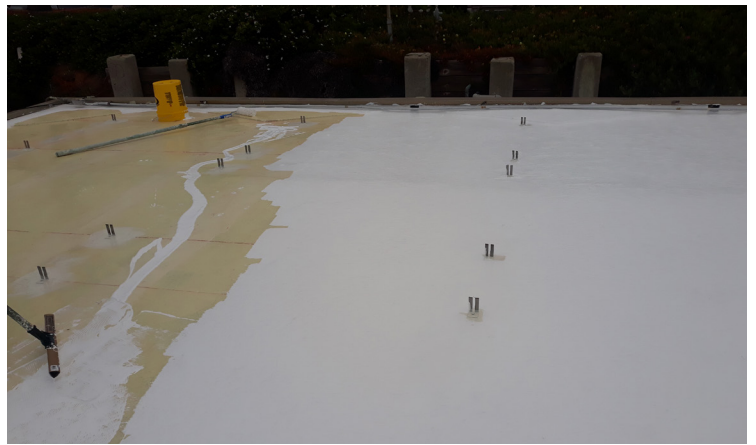
Whether due to improper installation or water incursion after the sealant began to fail, the texture layer of this dual cement layer system was separating from the smooth base layer. As a result, there was moisture trapped between the layers and there was no visibility to track leak paths.

Proven to bond extremely well with cement and a multitude of other substrates, Ecodur was an easy choice. Because Ecodur has no maximum curing thickness and can be thickened to a mastic grade, it works well to fill gaps, cracks, and holes from solar mounting.

By scraping off the entire loose texture layer, the crew was able to expose a relatively smooth cement layer that was still in good condition. Due to Ecodur's extreme adhesion, no primer was needed and Ecodur was also used to seal the new penetrations for the reinstallation of the solar system.
