## CASE STUDY: TPO APARTMENT

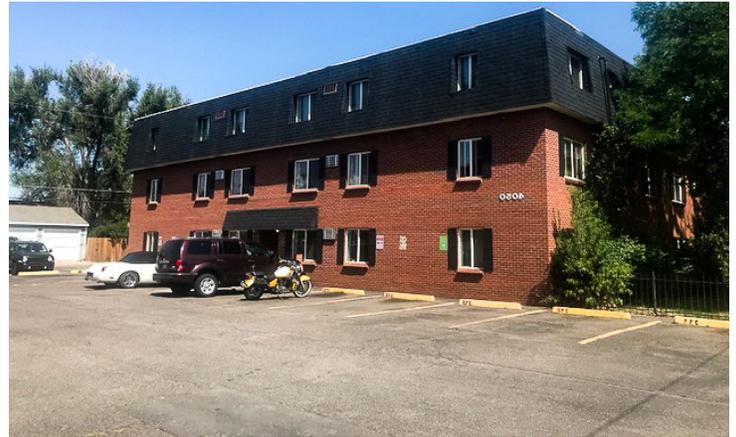
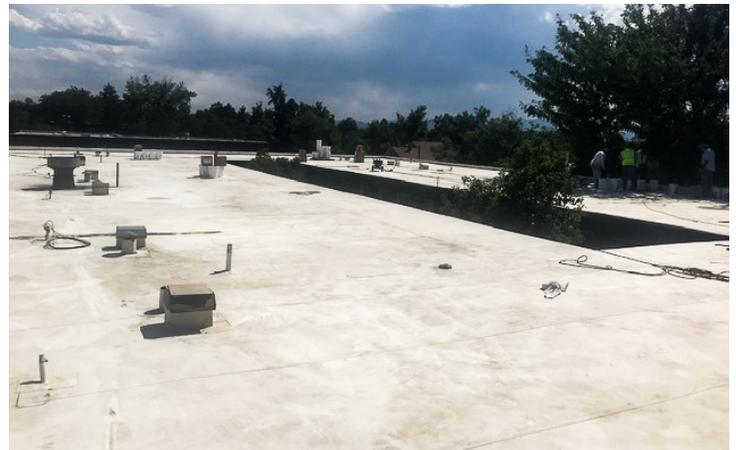
With the TPO membrane already in poor shape, pressure washing could exacerbate the problems and lead to damage in the second-floor apartments. Fortunately, Ecodur's extreme adhesion allows for installation without the risk or waste of water.

The crew began preparation by scrubbing areas with caked on dirt with a wire brush. Then they thoroughly swept and blew the entire roof deck.

First to get coated were edges, the short parapets, penetrations and other details. By leaving accessible tie-ins they were able to quickly coat the remaining field to a consistent thickness of 30 mils.

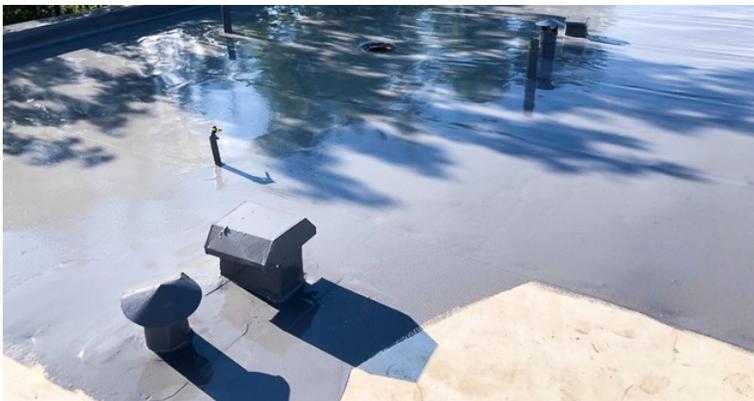
At a fraction of the cost of tear-off and replacement the apartment owner was able to put an end to the disappointing cycle of premature TPO failure. The tenants and their belongings will be protected for decades to come with a single application of Castagra's super tough Ecodur roof coating.
