## CASE STUDY: SKILLED NURSING FACILITY ROOF

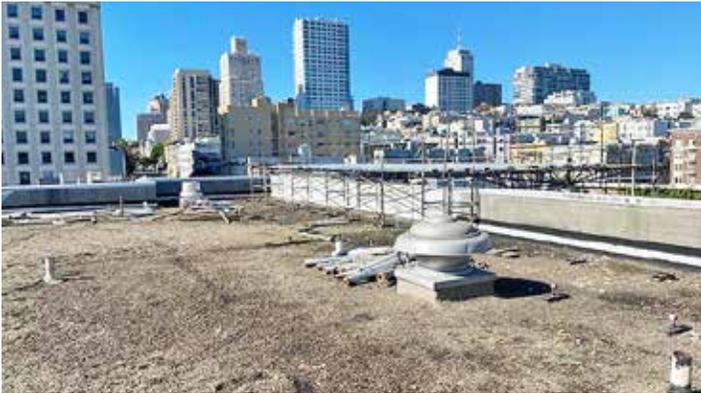
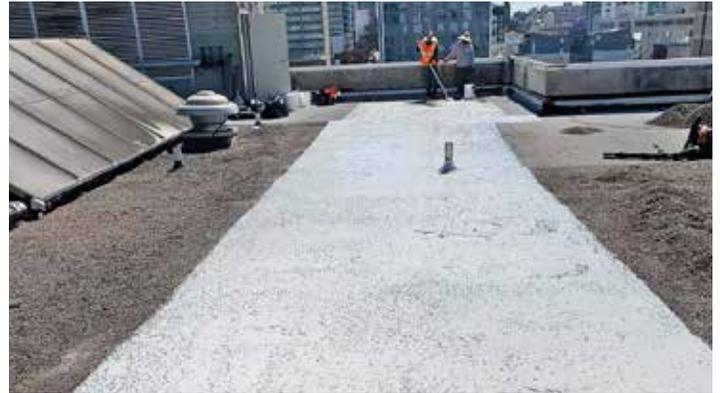
Located in downtown San Francisco, this care facility had an aging roof with multiple patches that continued to reveal new leaks with each rain. With multiple ponding areas, dozens of equipment, and even more penetrations, leak detection was hit-and-miss at best. Consisting of a built-up and gravel roof, the substrate posed significant challenges that eliminated many common options.

To start, nearly 90,000 pounds of loose gravel had to be removed using chutes to the surface 6 stories below. With the loose gravel removed, the crew ran power-brooms to agitate all nearly loose gravel and loosen any surface dirt and debris. Wire brushes were used to loosen any stiff or caked dirt and scrapers were used to break away all brittle surface anomalies. With another ton of gravel, dirt, and other trash removed, blowers were used to leave the surface clean enough to coat.

All details, penetrations, and other features were cut in first using Ecodur thickened with crushed walnut shells. To shorten the distance between gravel peaks and asphalt valleys, an initial coat of Ecodur was foamed using a safe, sustainable expanding agent. A second coat of Ecodur without additives was then applied in the opposite direction of the initial coat. Finally, a highly reflective, acrylic topcoat was applied to reduce cooling costs and reduce wear on HVAC equipment.

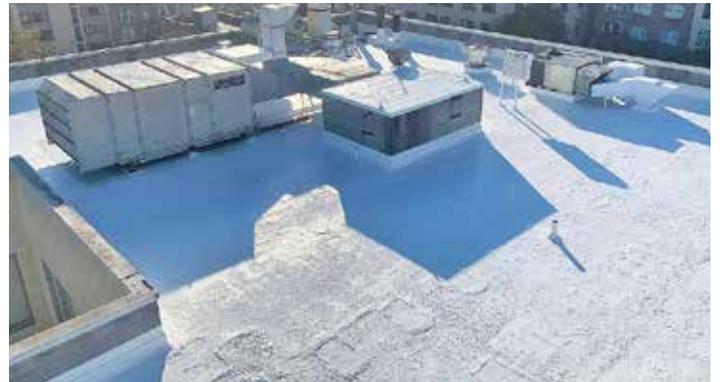
Because Ecodur Roof Coating is VOC-free, can be applied without pressure washing, and cures hard enough to withstand piercing from embedded gravel, it is a perfect choice for limiting tenant disruption and creating a durable, long-lasting waterproof layer.
