## CASE STUDY: ROOF DRAIN REPAIR

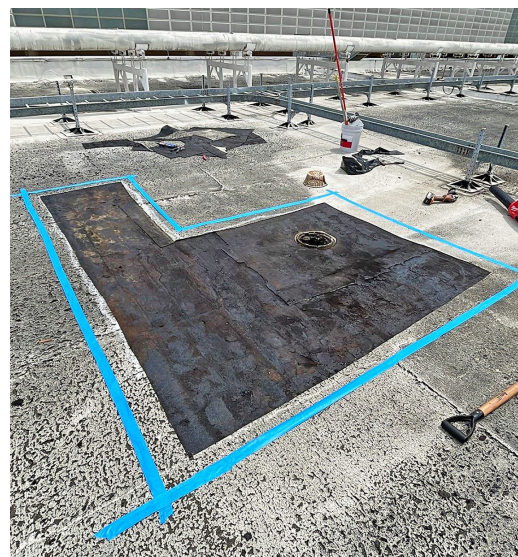
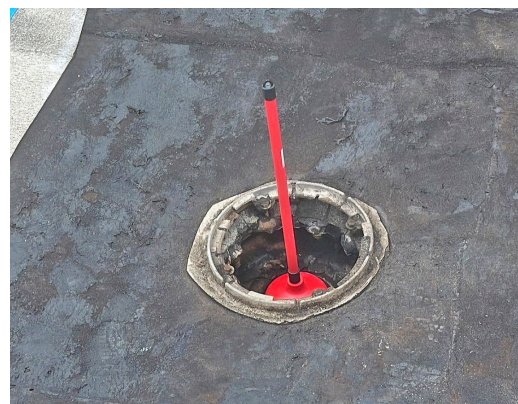
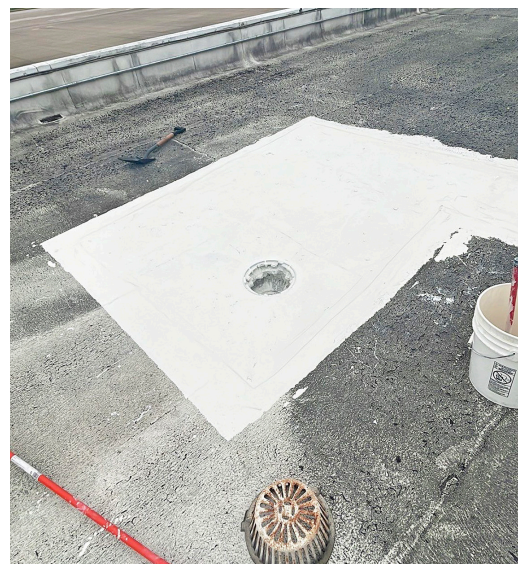
Finally, the rest of the repair area was tied in to a minimum of 30 mils of Ecodur+.

As the coating set up, the tape was removed, leaving a clean repair area. A shiny new drain cap was placed like a cherry on top of sundae.

Using moisture meters and cutting cores, the crew at **TrueWorks Roofing** (a **Castagra Licensed Company**) were able to determine the extent to which the membrane was trapping moisture between layers. They then cut away the upper layer and allowed the remaining layers to dry completely, as verified with further moisture scanning.

With the repair area clean, dry, and in sound condition, they moved onto the drain itself.
