# CASE

## Problem

## Solution

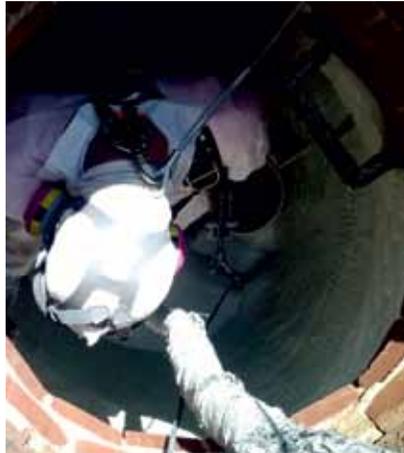
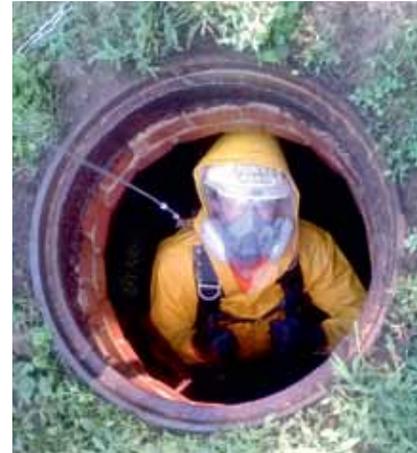
The manholes were coated almost in their entirety from the trench to the top of the lid casing. The underside of the lid is not coated, just the top of the casting.

VOC-free, solvent-free has been used in seven locations in water and waste-water environments in Tennessee and Kentucky, including manholes for Harpeth Valley Utility District, the cities of Brentwood, Franklin and Portland, and settling basins for the Turney Center Maximum Security Prison and the City of Kingston Springs, and also for secondary containment for the Louisville Water Department.

The rapid cure time eliminated much of the sewer backup occurring due to line plugging, or costly bypass pumping being required. With Ecodur, the manhole was returned to service as soon as it was coated and the applicator person had left it. Epoxies typically took four hours.
