CASE STUDY: CANNABIS ROOF

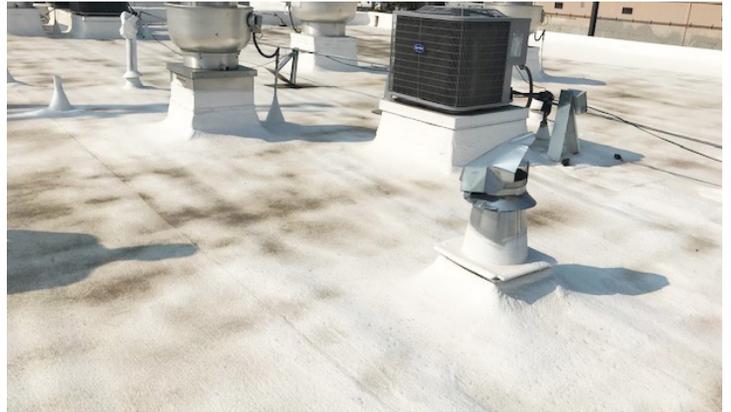
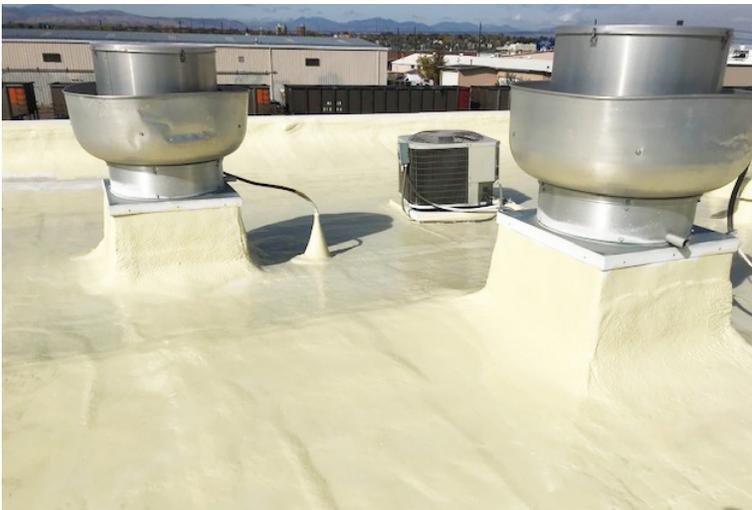
This large indoor farm, previously used as a warehouse, had a relatively new SPF roof. But it was already leaking. Perhaps due to hail or animal damage, the existing acrylic coating was damaged in several locations allowing for water incursion. Because cannabis cultivation facilities face strict scrutiny, they cannot allow any potential contamination from outside water, or organic growth it can create. The owners knew they needed to find a permanent, low maintenance solution that would not require tear-off or risk contaminating their crops.

Initial site prep consisted of thoroughly sweeping the entire roof deck and wire brushing any low spots or other areas with caked-on dirt present. Any areas of wet or damaged foam were cut out before filling any voids and blisters with Ecodur. Because Ecodur has no maximum thickness, it is an excellent choice for filling. Finally, it was time to coat the remaining roof deck. Using a squeegee and rollers, Ecodur was applied to a consistent 30 mils. With 100% solids, it quickly cured to the same thickness.

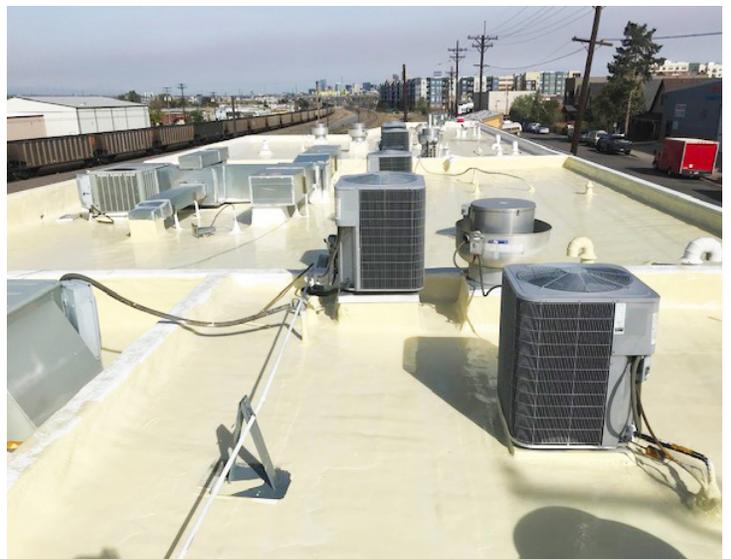
With Ecodur roof coating's extreme adhesion, it bonds better to swept surfaces than regular coatings adhere to pressure washed and primed substrates. This eliminated the risk of water contamination during the project. Because Ecodur is VOC free, it was safe to apply near the HVAC units which supply the majority of the buildings carefully controlled air. Also used as a liner on some of the largest municipal water tanks, low spots and ponding areas are no threat to Ecodur's seamless surface. Because it is easy to apply manually, there was no risk of overspray.

Leaks were fixed, problem areas addressed, and future problems were prevented, all without any disruption to the operations below. Ecodur roof coating will provide decades of protection with minimal maintenance.
