CASE STUDY: MECHANIC SHOP

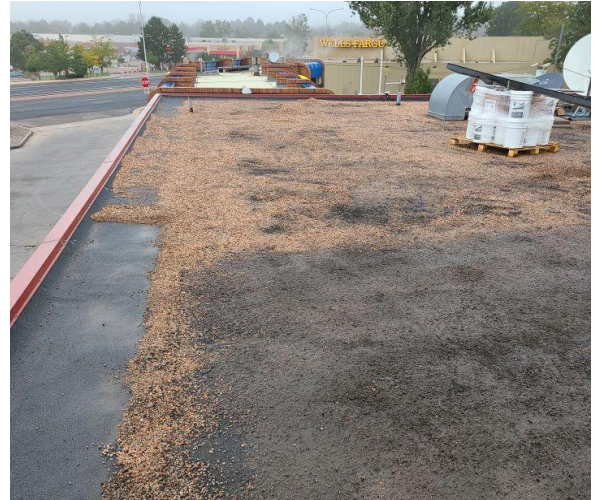
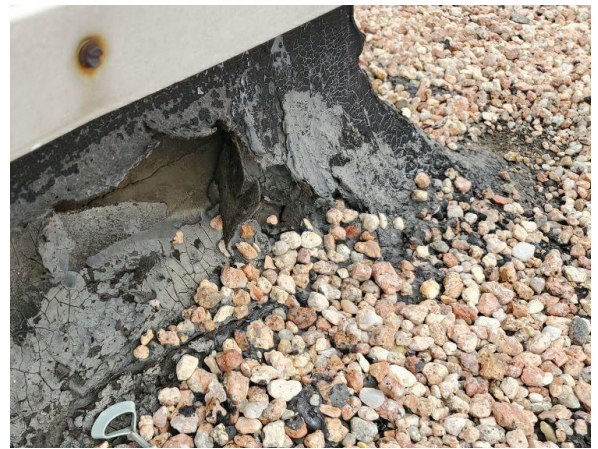
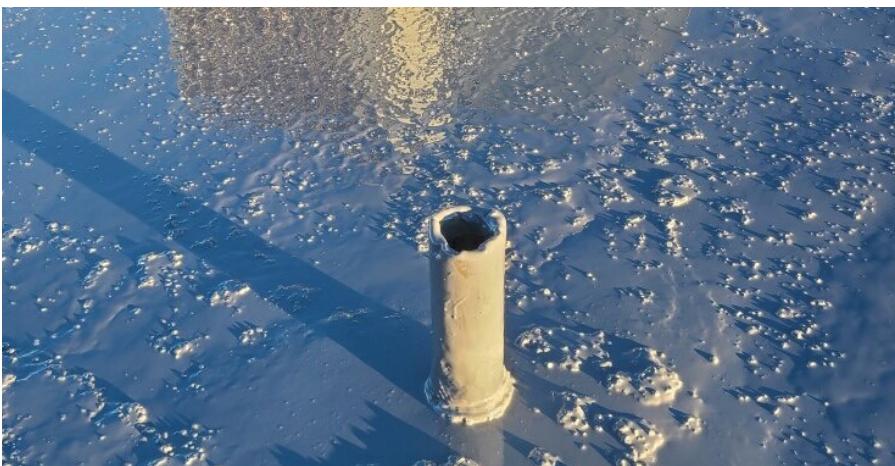
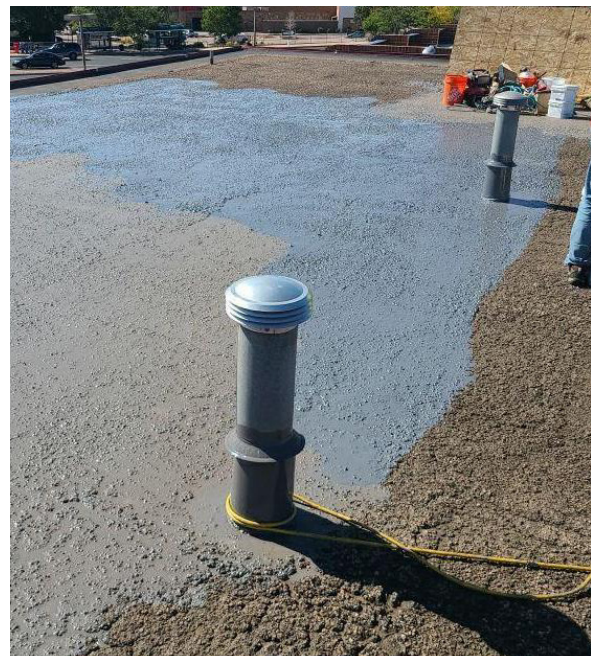
With a leaking roof full of tears, cracks, and pinholes, the owner needed to find a solution that minimized disruption below. With a 7 day a week schedule, downtime was not an option. The owner needed options that would not only allow the business to remain open, but would keep the employees, customers, and property below safe.

To prevent flying gravel from hitting a person or their car, all loose gravel was manually removed before running a power broom over the entire roof deck. With the surface clean, dry, and tight, the crew began working on detail.

While one member worked on perimeter edging, others focused on penetrations, HVAC pads, and substrate repairs. With the details and damaged areas addressed, it was time to move on to the field.

The field was coated by pouring Ecodur roof coating directly onto the roof and rolling to the desired 30 mils. From start to finish, this project took only a day and was completed before a storm moved in the following day.
