CASE STUDY: STORAGE UNIT ROOF

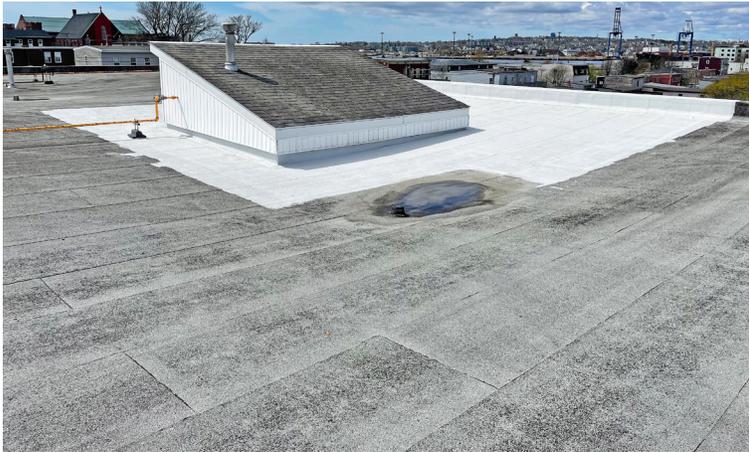
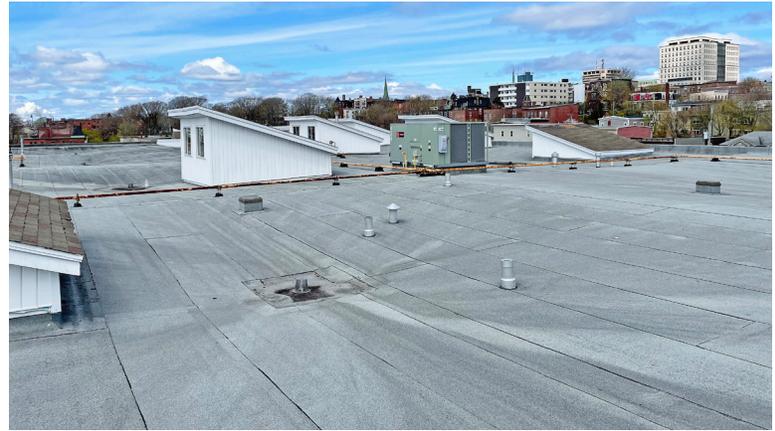
This facility in beautiful St. John, New Brunswick is home to hundreds of individual units. With nearly 100 inches of annual snowfall and an additional 55 inches of rain, even small leaks get lots of water. With hundreds of units and countless fortunes being stored below, the owners are very aware that leak damage can be detrimental.

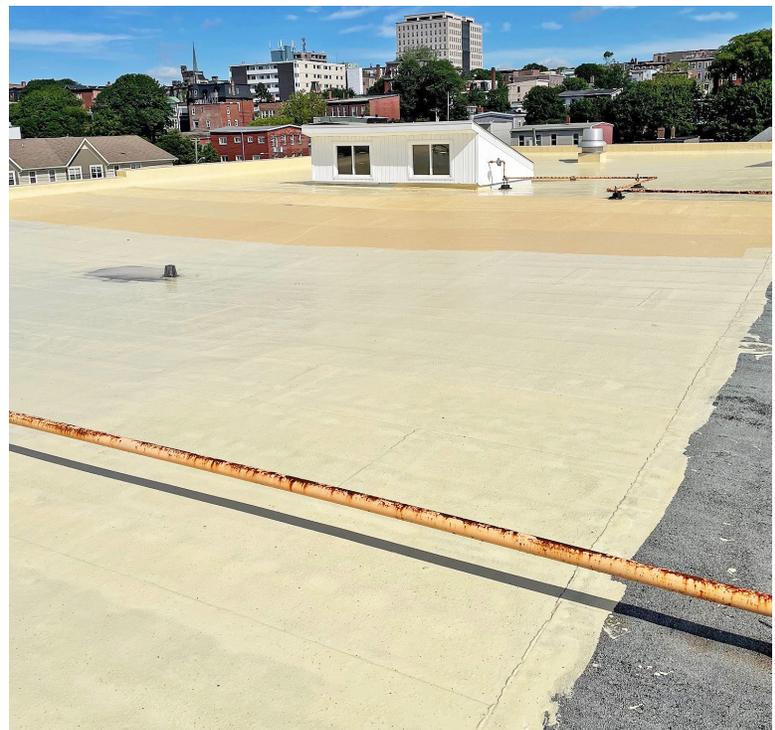
Using a power broom and blower, the contractor thoroughly cleaned the roof deck, paying extra attention to cleaning the drains and penetrations. Using a squeegee and rollers they applied Castagra's Ecodur Roof Coating to a uniform 30 mils. With rain coming the first evening of application, the most leak prone section in the middle was targeted first. It did rain that night, but the coating was unaffected as Castagra's Ecodur is waterproof immediately upon installation. As soon as the roof was dry again, the other sections were tied in. Because Ecodur has an infinite recoat window, the newly applied Ecodur readily bonded with the existing coating.

By targeting the worst sections first, the contractor was able to prevent further damage from the coming storm. After the storm, the roof was completely coated creating a permanent water barrier that will keep the stored items safe for decades to come.
