CASE STUDY: COMMUNITY COLLEGE CEMENTITIOUS ROOF

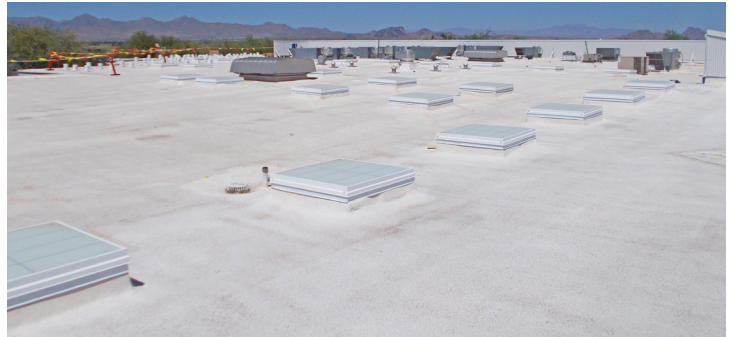
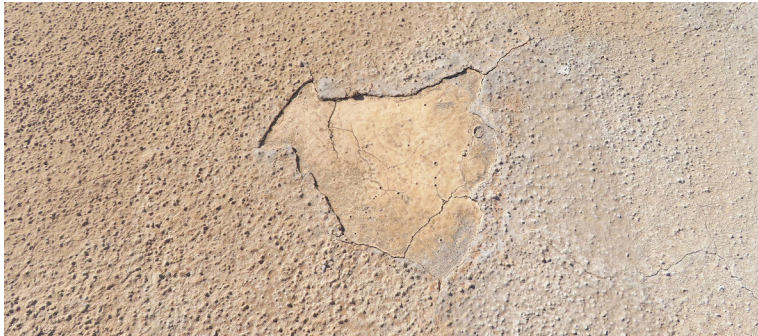
Like most roof systems, cementitious roofs require regular maintenance. Also like most roofs, cementitious roofs are frequently ignored. After an impressive 20+ years, most cementitious roofs reach the natural end of their unmaintained lives. Unfortunately, most rejuvenation coatings do not bond to the aged acrylic-modified cement.

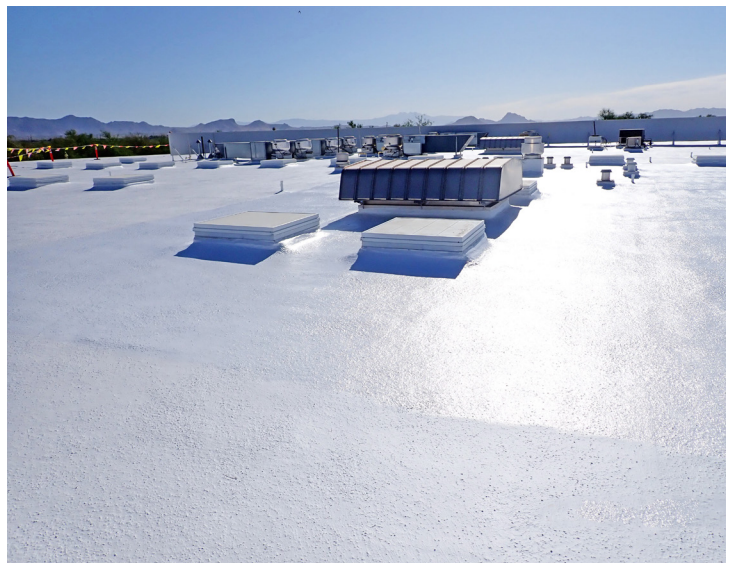
After all detail work was completed, Ecodur+ was applied to a minimum of 30 mils, creating an additional tough outer shell that will protect the cementitious roof for decades to come. Finally, the entire project was given a bright-white acrylic topcoat that will reflect the harsh Arizona UV and aid the SPF in keeping the occupants cool and comfortable.

First, the entire roof was thoroughly cleaned by the qualified team of Castagra Certified Applicators at Johnson Roofing. Next, foam blisters were cut and filled with Ecodur+ Roof Coating. Because Ecodur+ has no maximum thickness, it makes blister filling easy. All loose, spalling, cement was removed to prevent coating over a layer that was poorly bonded. Reinforcing fabric was used to tie in existing flashing and prevent future movement.
